# HONDA CABLES

Installing parking brake cables on a Honda SI

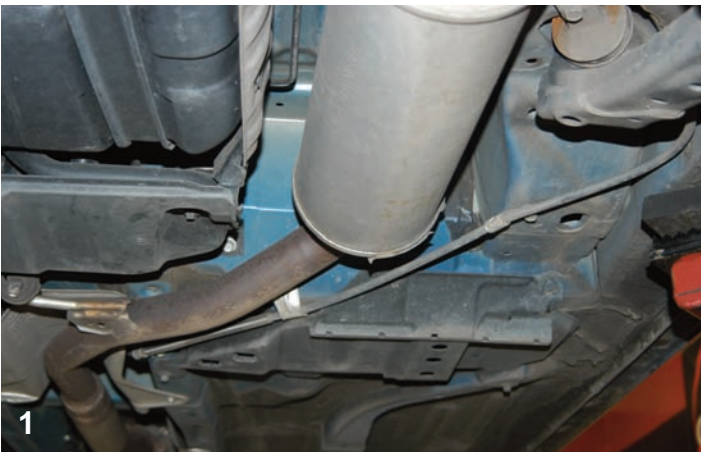
The original cables are routed under the car and are held in place with metal brackets that are connected to the underbelly. The brackets hold the cables in place and away from the hot muffler system.

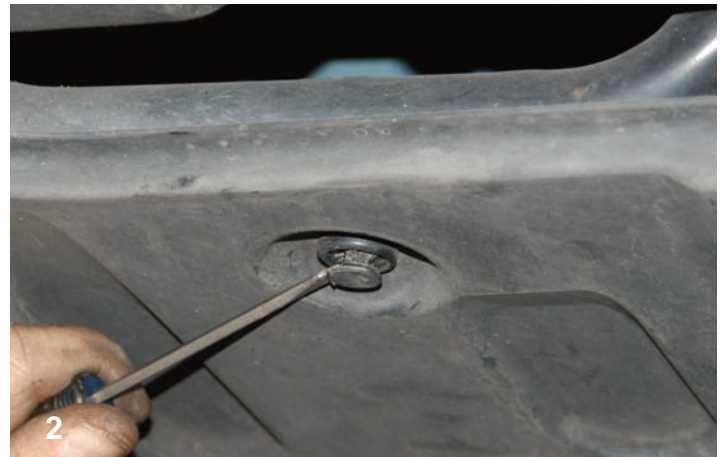
The Honda has a large plastic panel that covers the brake cables on the driver's side of the car. In order to access the brake cable connections the panel was removed. Certain sections of the panel are fastened with plastic pop-in fasteners.

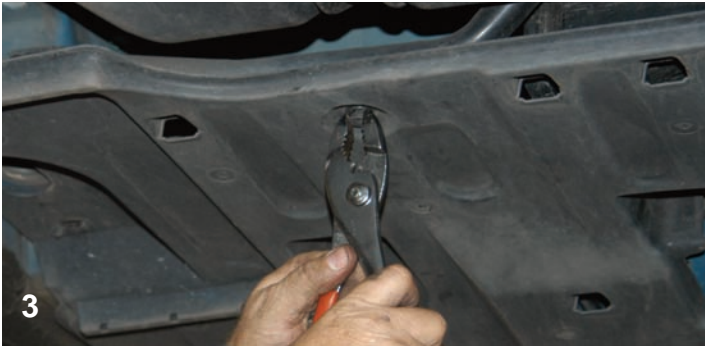
Being careful not to damage the fastener, they were pulled out of their connection with pliers. Some come out easily while others are more difficult.

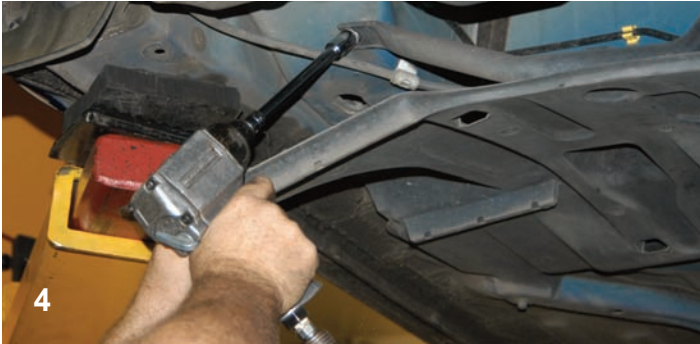
There is a stiffening bracket that keeps the plastic panel in place and minimizes any flexing, so it had to be removed next. Here the bolt is being removed with an impact gun and the correct size socket.

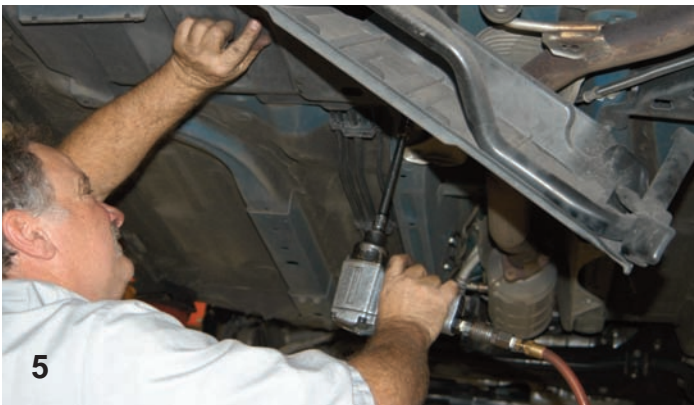
The front of the plastic panel is secured with several small sheet metal bolts. Here the bolts are being disconnected so the panel can be removed.

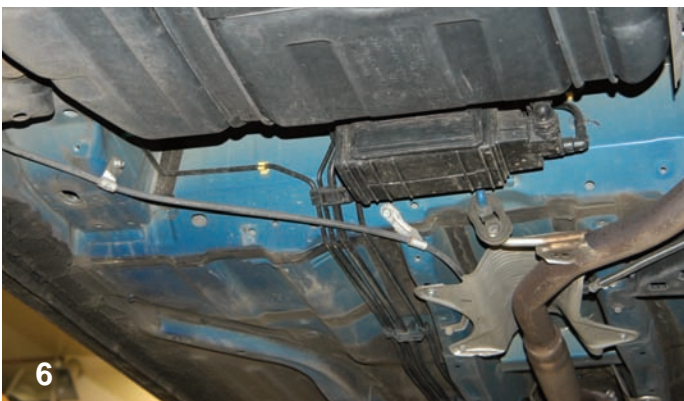
The panel was removed and now the connections for the driver's side cable are easily accessible.

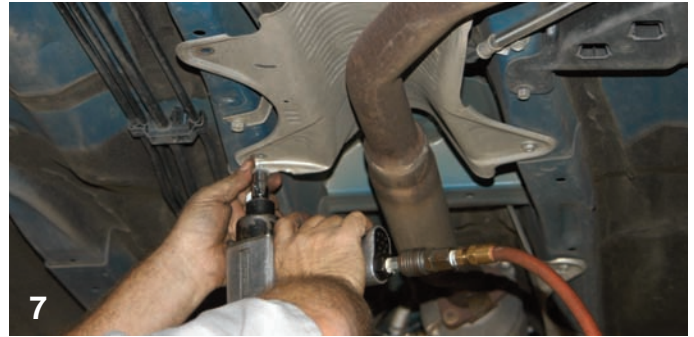
The brake cables run to the side of the exhaust heat shield and up into the car. The heat shield was removed to access the cable entrance into the car.

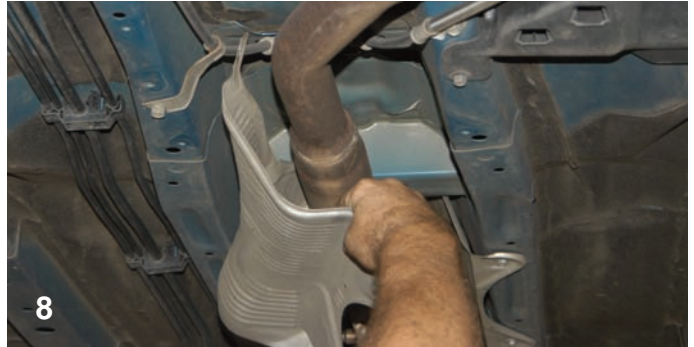
After the heat shield was removed, you can see how the cable enters the car through two rubber grommets.

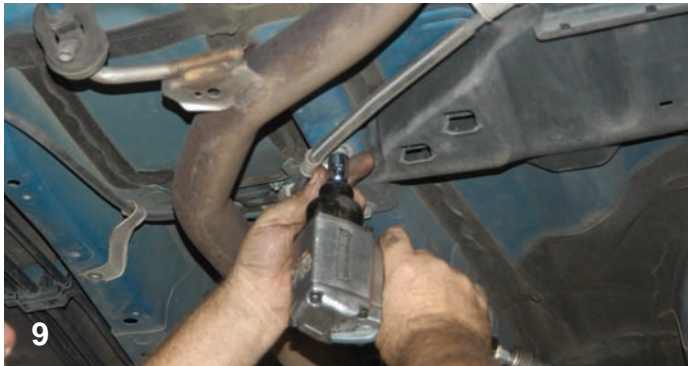
All of the brackets that secure the cable to the underbelly were removed with an impact gun. Keep the brackets in good condition because they will be reused on the new cable.

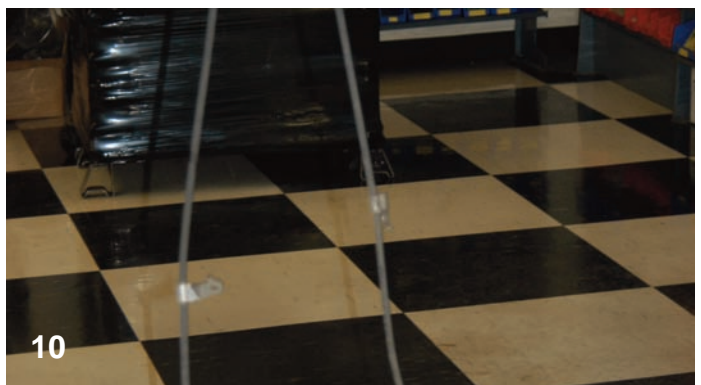
After the cable brackets were removed, there was enough slack to disconnect the cables from the original disc brake cable mechanism. The lines were left to hang but they will be used as a guide later when the brackets are installed on the new cable.

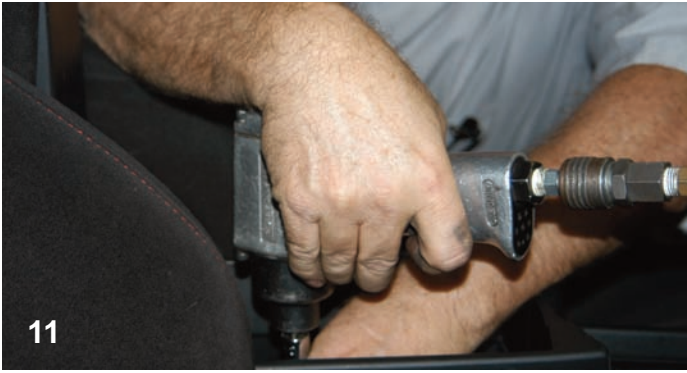
11

The console had to be removed next. Here the two rear bolts are being removed from the console. Part of the console uses bolt connections and part of it just snaps together.

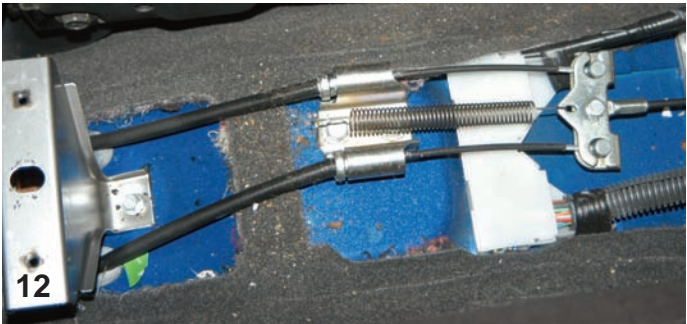
12

Looking under the console you can see the two cables entering the car and the bracket the cables fit into. The cable lines connect to the balance mechanism, and it connects to the parking brake handle.

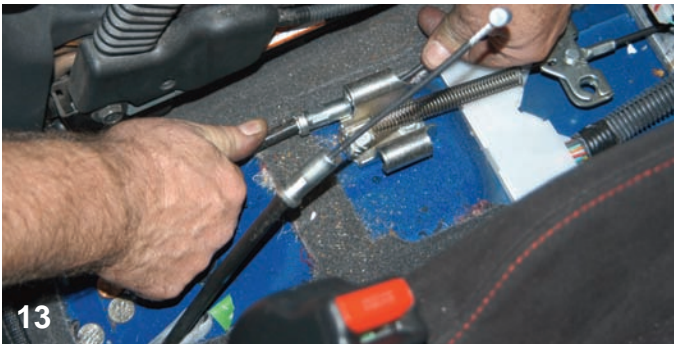
13

The cable ends were pulled out of the bracket and then the lines were pushed out of the car. The rubber grommet popped out and then it was easy to route the lines out of the car.

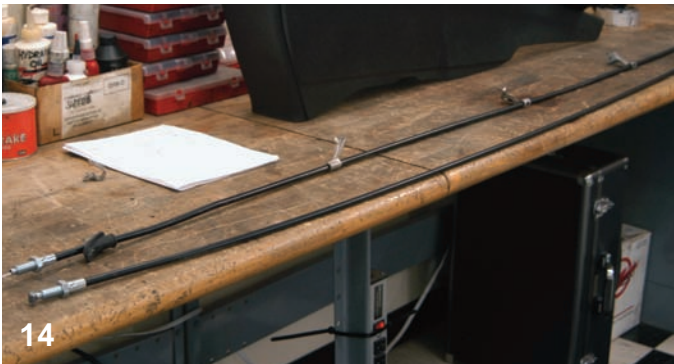
14

Using the cables as a guide, the brackets were transferred to the new Wilwood lines. It's important to keep track of the sides so the brackets can be fastened to their original location.

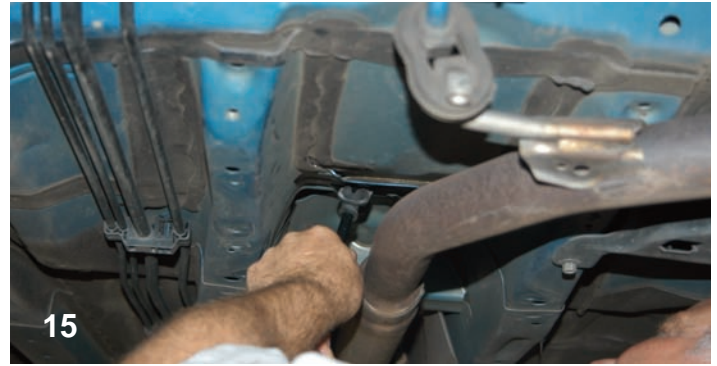
15

The rubber grommet was mounted on the line and then it was pushed back through the hole in the floorboard so the connection can be made to the original bracket.

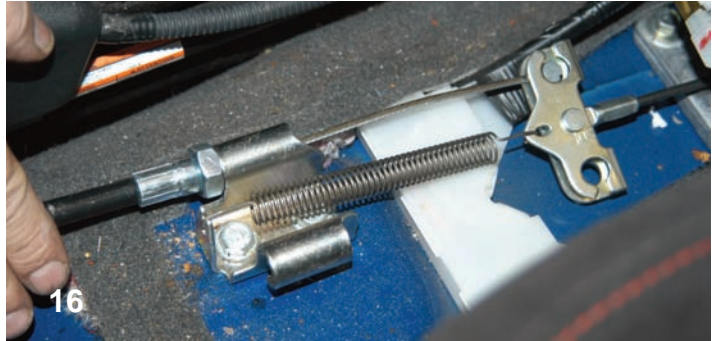
16

The Wilwood cable end fits into the original bracket just like a factory installation.

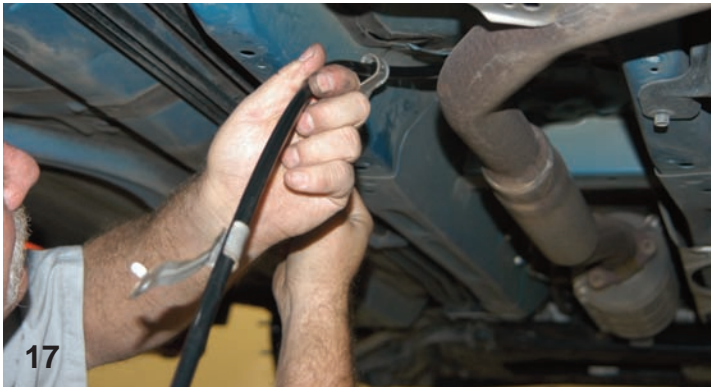
17

The Wilwood cable was routed back to the rear brake calipers. The front bracket was secured first to keep it out of the way, while the second cable was being installed. The rubber floor grommets were reused for this installation.

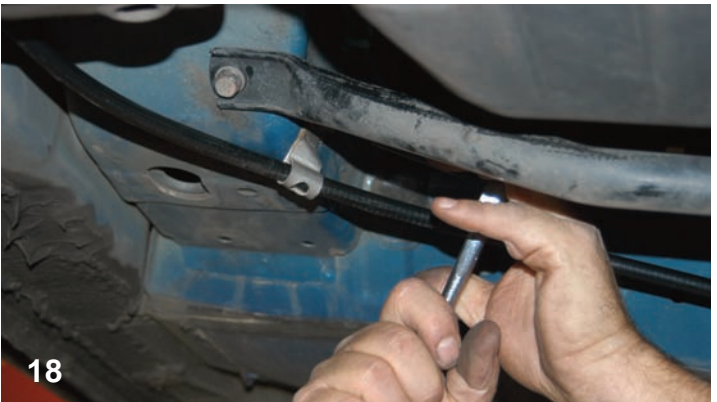
18

After both cables were in place, the brackets were screwed back into their original location. Here the bracket is being secured with the original sheet metal screw.

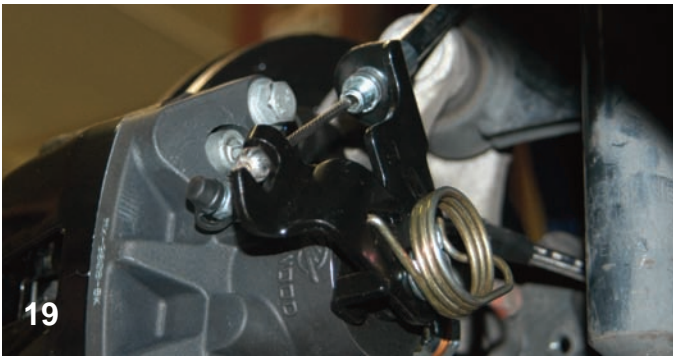
The other end of the cable fits through the bracket hole and the cable end fits into the mechanism lever. When the lever is pulled back the parking brake is applied.

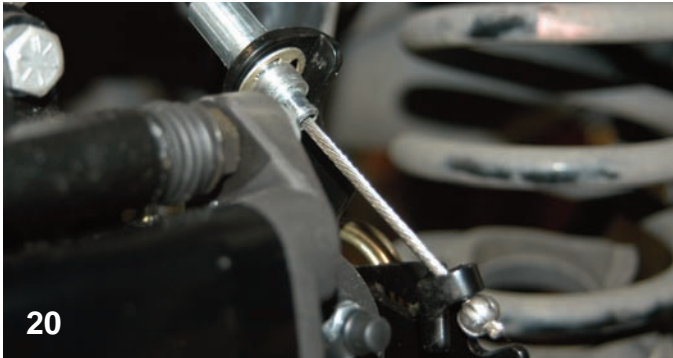
A close look reveals the C-clip that holds the cable end securely in the bracket.

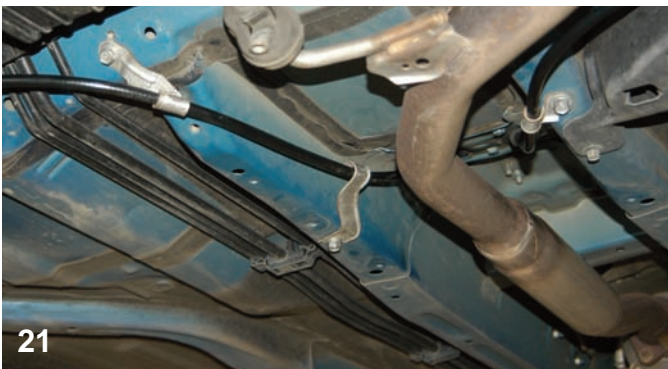
Looking under the car you can see the cable being routed from the inside of the car back along the undercarriage. The original cable brackets work great with the new cable.

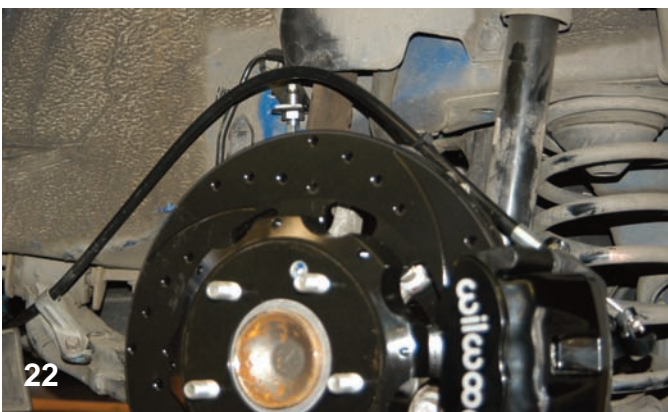
The cable is held at the front with an original bracket and then it runs to the caliper bracket. A small plastic tie wrap is used to keep the cable in place as it crosses over to the caliper.

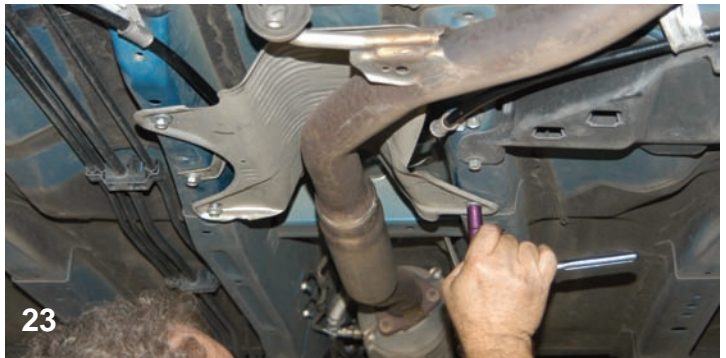
The exhaust heat shield was reinstalled and the bolts were secured with a socket wrench and the correct size socket.

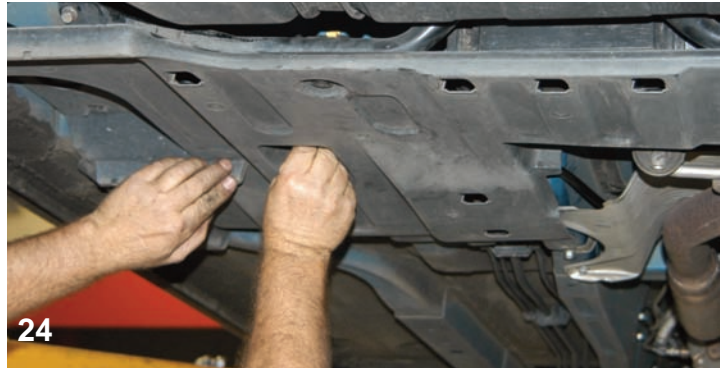
The plastic panel was installed using the fasteners that were carefully removed. Here one is being popped in place.

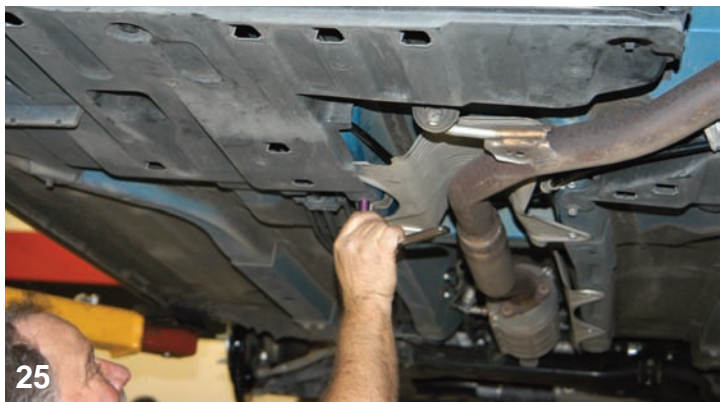
The front of the plastic panel was secured with the original sheet metal bolts.

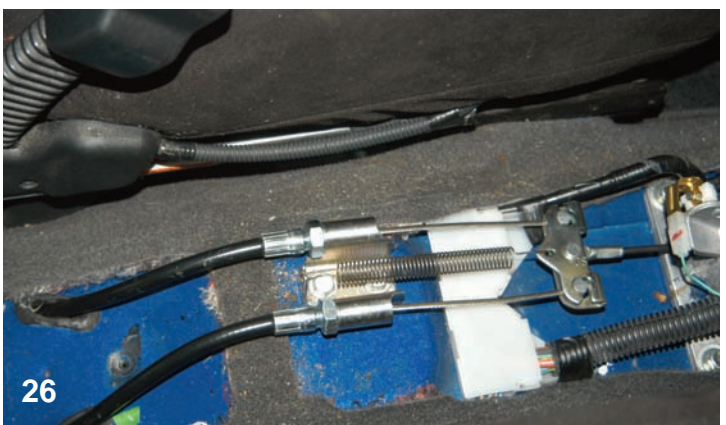
Looking inside of the car you can see the two cables routed perfectly into the original Honda brackets. This looks like a factory installation.

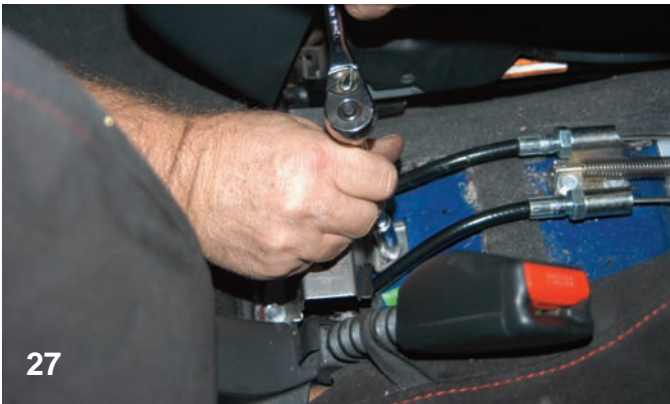
The rear console bracket that was removed to access the holes in the floorboard was reinstalled. Here the bolts are being secured with a socket wrench and the correct size socket.

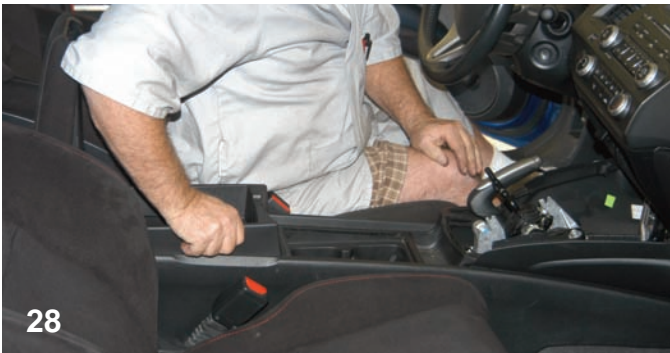
The console was placed back into the car and the holes were lined up with the floorboard brackets.

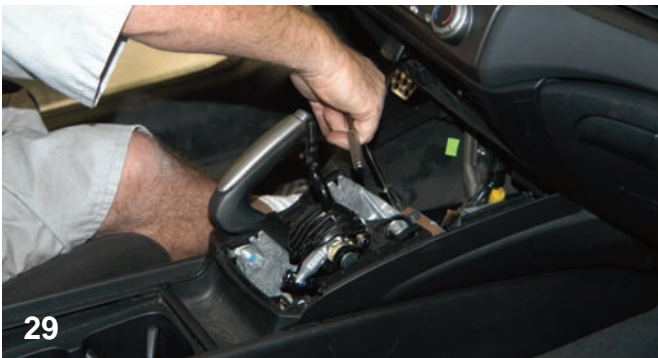
Here the front of the console is being connected to the floorboard bracket. The top part of the console snaps in place.

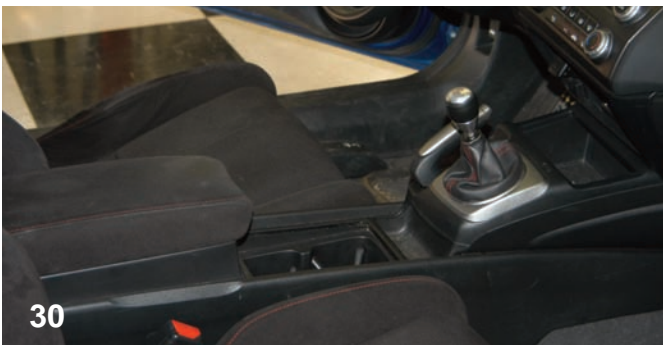
Here is the console in place and ready for a cruise around the block to bed in the brakes. Most of the cable installations are easier than this one that required console removal.
